EO REPORT ATTACHMENT ©
AUGUST 23, 2007 MEETING
SPRAY IRRIGATION DISPOSAL AREA
ACCESS POINTS AND SIGNAGE PHOTOS

California Utilities Service - Update regarding disposal area access and signage

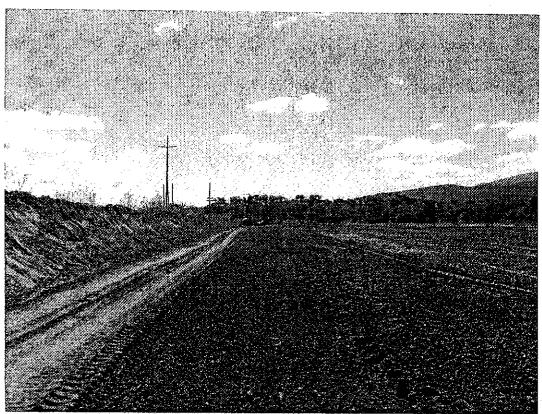
Figure 1: Berm/embankment and service road (on left) separating agricultural field (not seen)

from spray irrigation disposal area (on right)

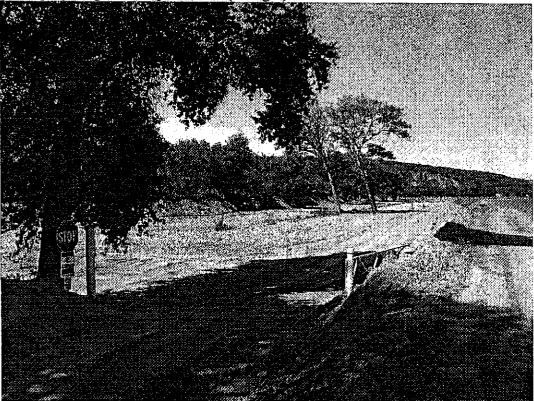
Figure 2: Gated access to disposal area (south from HWY 68); service roads and berm/embankment separating disposal area from agricultural fields (on right)

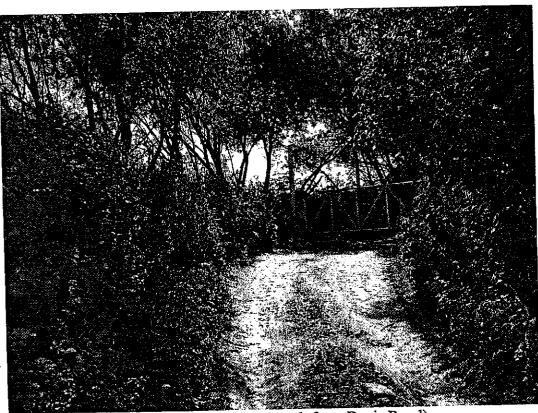
Figure 3: Gated access to disposal area (north from Davis Road)

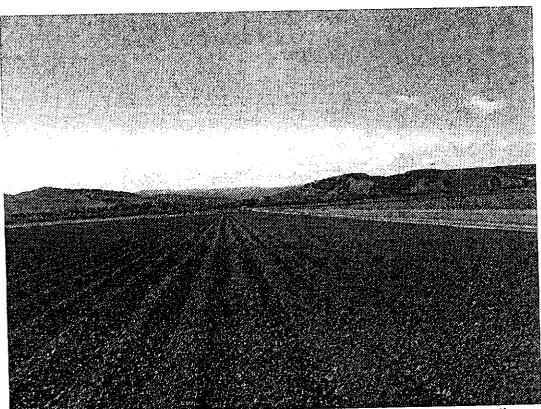
Figure 4: Agricultural service road (on right) from HWY 68 leading up to disposal area in the distance

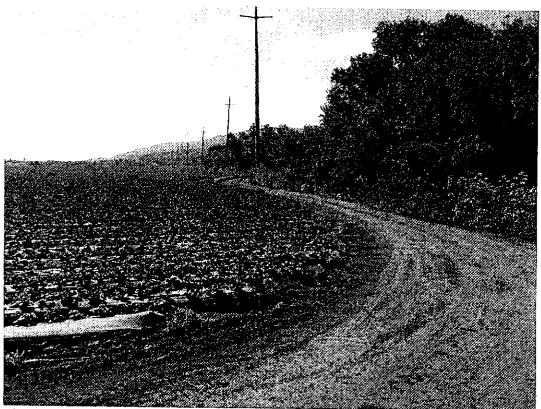
Figure 5: Agricultural service road from Davis Road leading up to disposal area beyond tree line on right

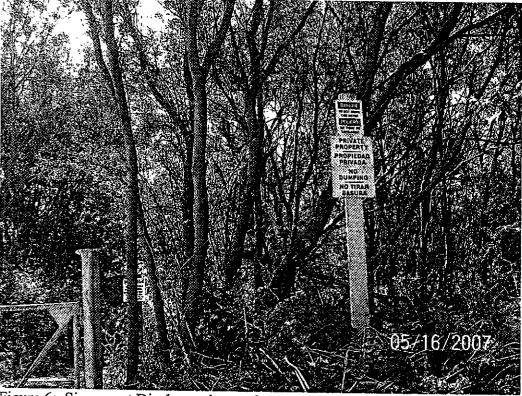
Figure 6: Signage at Discharger's gated access road along Davis Road

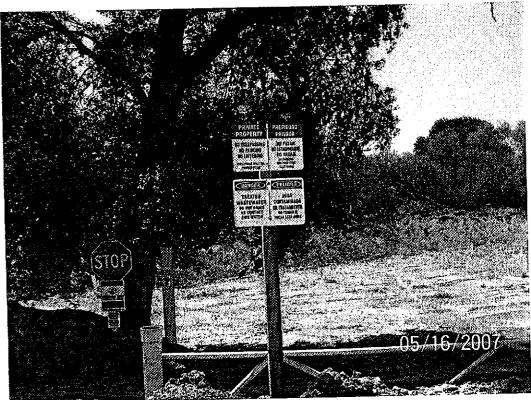
Figure 7: Signage at Discharger's southern (HWY 68) access gate

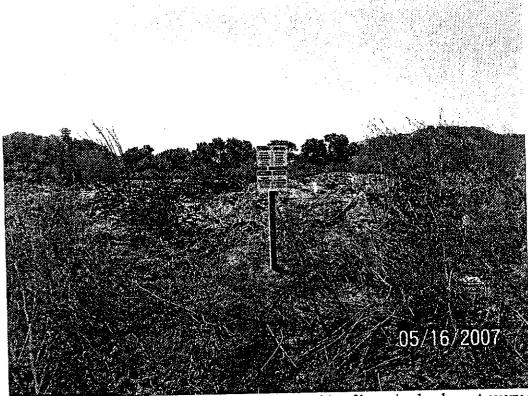
Figure 8: Signage on agricultural service road side of berm/embankment every 500 feet

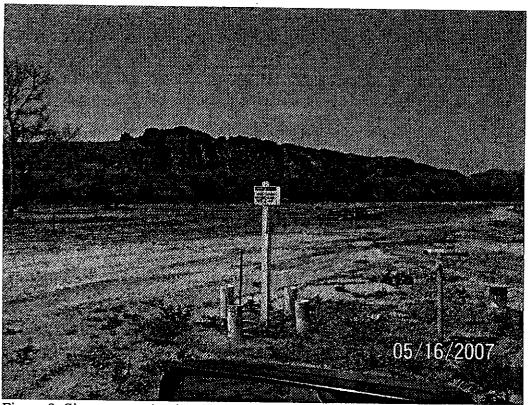
Figure 9: Signage at valve junction and riser

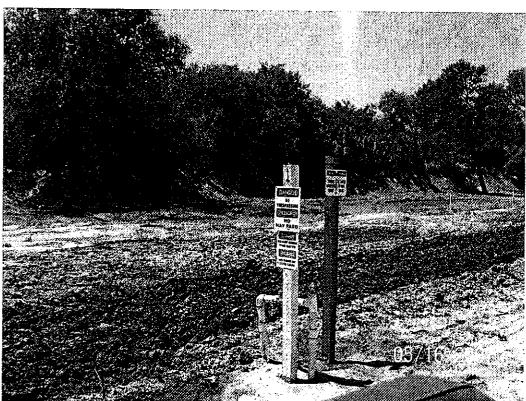
Figure 10: Signage at valve riser

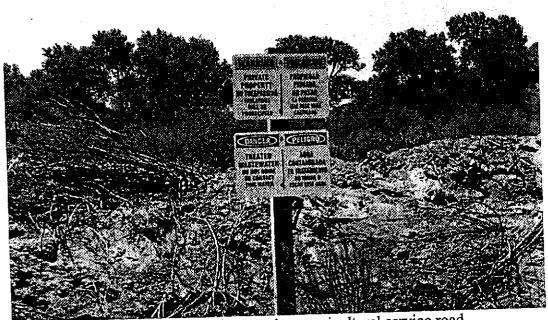
Figure 11: Close up of typical signage along agricultural service road
